# CASE STUDY

## 7" HELICAL PILE SOE AND UNDERPINNING FOR A 100-YEAR-OLD COMMUNITY CENTER

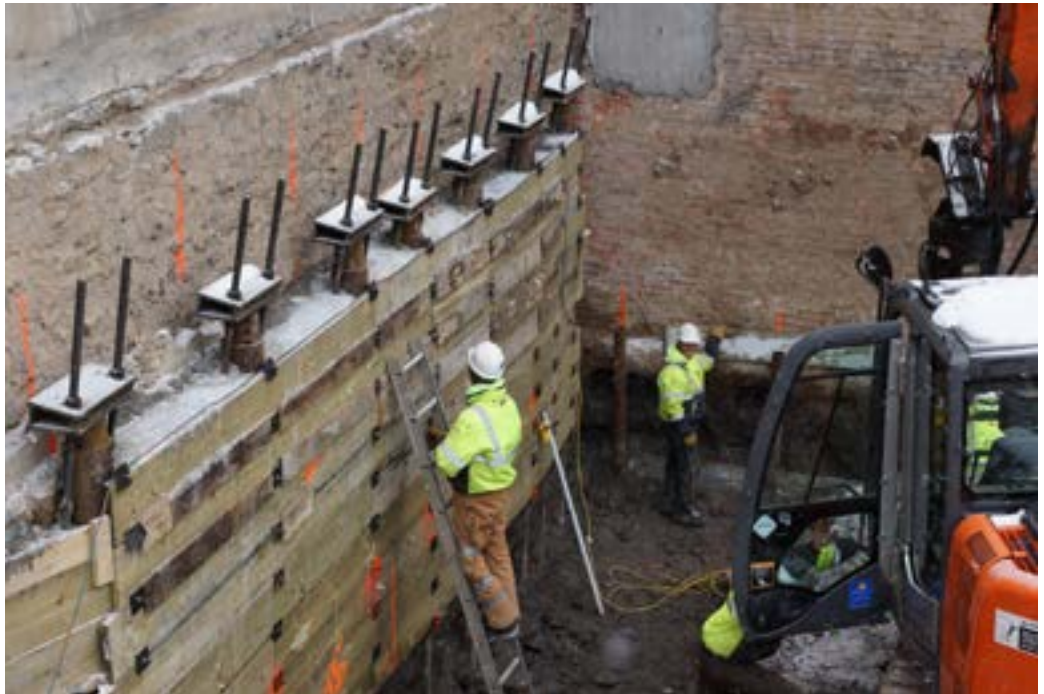
CMI Structural Solutions proposed a solution for the retrofit, underpinning, and shoring of the 100-year-old community center. This included the use of helical piles and Counterforce underpinning brackets from Ideal. To stabilize the structure, CMI installed fourteen 7" OD x 408" WT and 4.5" OD x 337" WT helical piles. The piles were installed to 20-foot and 30-foot depths. Counterforce underpinning brackets were used at each pile location. Once all of the piles were installed, timber lagging was attached to the face of the piles as the excavation continued. A unique feature and advantage of this temporary shoring is that the timber lagging can be removed as the excavation is backfilled, and re-used elsewhere in the future.

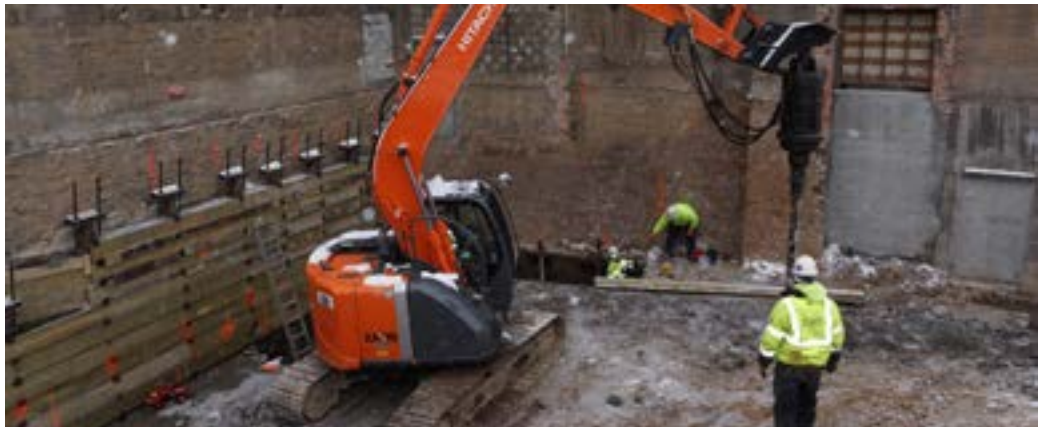
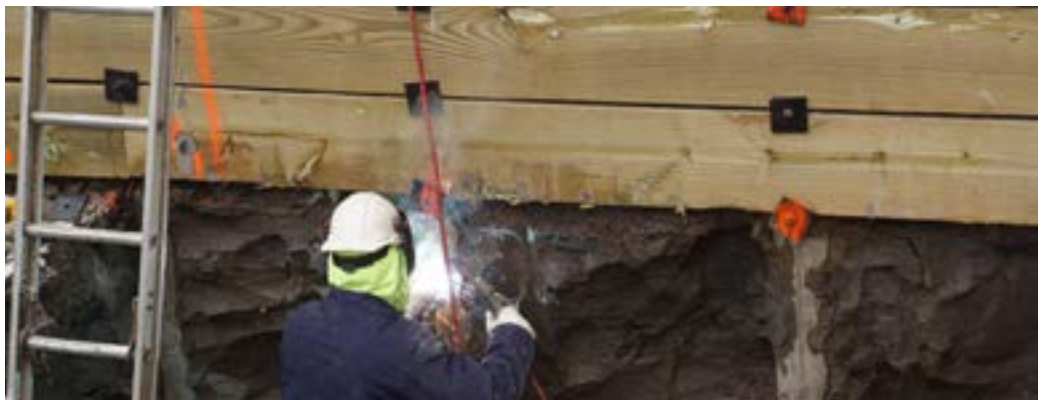
**WITH PREVIOUS SINKHOLE ACTIVITY ON SITE, THE PILES HAD TO BE DRIVEN TO BEDROCK TO ENSURE ZERO MOVEMENT SHOULD THE SOILS DISAPPEAR.**
