CASE STUDY

94 STELCOR PILES FOR 10 STORY HOUSING PROJECT ON ROCKY CONTAMINATED SOILS IN THE BRONX

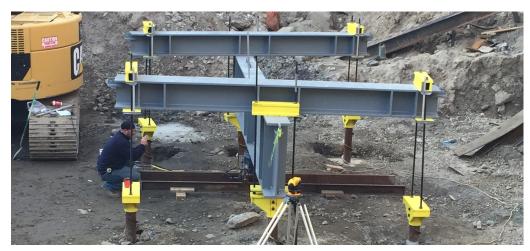
ONLY **SIX TENTHS OF AN INCH** NET SETTLEMENT AFTER 24 HOUR LOAD TEST AT FULL LOAD OF 200 TONS!

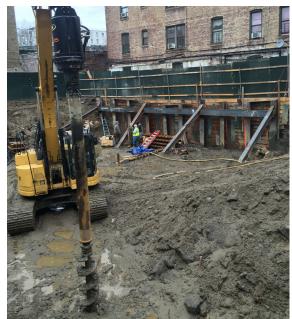
PILES INCREASED FROM 1.5 DRILLED SHAFT CASE PILES PER DAY TO UP TO 8-9 STELCOR MICROPILES PER DAY

SOLUTION: Rich Anastasio teamed up with IDEAL to present STELCOR as an alternate. In order to bypass the boulders and rubble in the soils, each pile location was rock drilled with an 18" diameter down-the-hole hammer and then pre-augered to 18'. A 70k drive head was used to install the piles to a depth of 40'. Two full 200 ton load tests were performed using 6 reaction piles each. The full 200 ton load was applied to the 40' test piles and after the 12 hour hold period, total settlement was approximately six tenths of an inch. Upon initial unload and rebound total settlement was around three tenths of an inch. The first and second load tests showed a net settlement of 0.312" and 0.268" respectively. The production piles were installed at a rate of 8-9 piles per day and 5 on the slowest day. This resulted in a significant cost and time savings with no spoils.
