CASE STUDY

NYC - 12.75" SOE HELICAL PIPE PILES WHERE THE LEANING TOWER OF SOHO ONCE STOOD

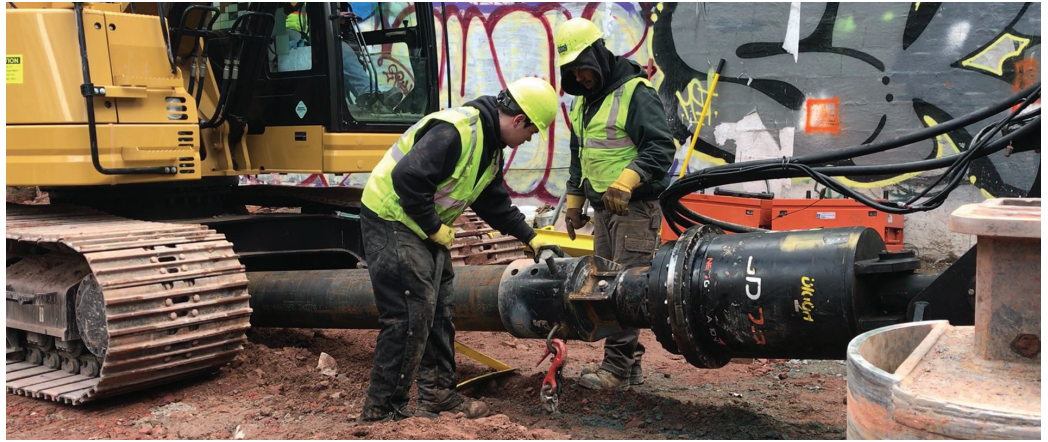
DESPITE HAVING TO PRE-DRILL THROUGH A GRANITE LAYER AT MANY PILE LOCATIONS, HELICAL PIPE PILES REMAINED THE MOST COST EFFECTIVE PILING METHOD FOR THIS SITE.

Rich Anastasio of EMC and the IDEAL team suggested a 12.75" x .500" W.T. helical pipe pile with a 22" x .75" helix as an alternate. The bolted coupling met the bending moment requirement and there was no resulting water and mud mess on site. A granite layer was present on one side of the site and all of the pile locations had to be pre-drilled in order for the piles to bypass this layer. While this resulted in increased install time, 33 helical pipe piles were installed over 10 days and remained the most cost-effective alternate. Each pile section consisted of an 18' lead and an 18' extension and was installed to 23' below excavation using a Digger SD95 hydraulic drive head. Post-installation, the piles were filled with 4,000 PSI concrete. Only time will tell what sort of destructive shenanigans the neighbors might get up to in the future. As for 74 Grand, she's gonna be alright.
